Onlays and crown for lower right quadrant using model free digital workflow

3Shape TRIOS intraoral scanner 3Shape Dental System

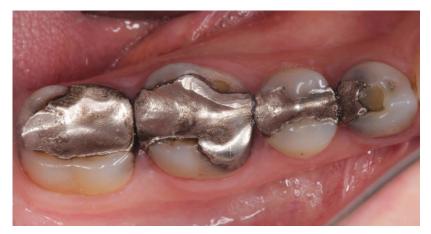
Fig. 1 (i)

Patient situation before (Fig. 1i, ii)

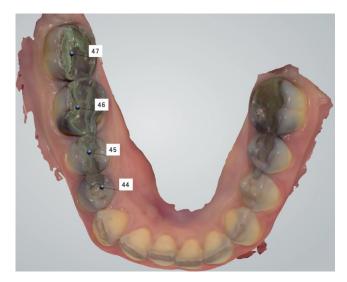
Fig. 2

All intraoral scanning was carried out using a 3Shape TRIOS 3 intraoral scanner.

Pre-preparation scan. (Fig. 2)

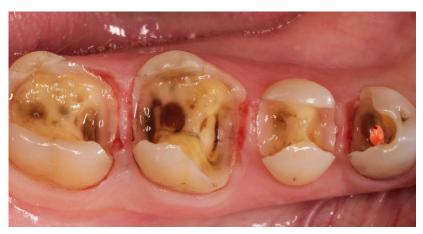
Fig. 3

After removal of the old restorations. (Fig. 3)

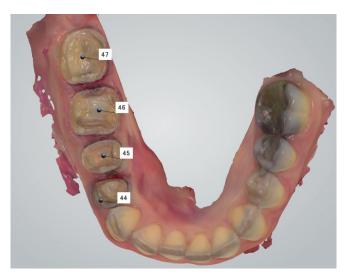
Preparations stitched into the existing scan. (Fig. 4)

The biggest challenge I found during this case, was scanning adjacent subgingival margins and getting a clear marginal definition all the way round the preparation. I found that by placing the retraction cord one tooth at a time, and then scanning it, then removing the retraction cord from that tooth and placing it in the next tooth, I was able to avoid the cord displacing the papilla over the margin of the tooth in front. Fig. 4 – shows the individual tooth prep scans stiched together into one scan.

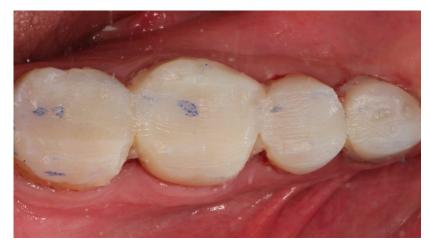
Fig. 5

Chairside Provisionals made from pre-reparation matrix of teeth. (Fig. 5)

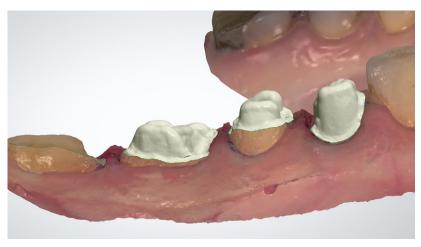
Fig. 6

The patient was rebooked for the fit appointment two weeks later. The laboratory stages were carried out using 3Shape Dental System. Virtual Die stage (Fig. 6)

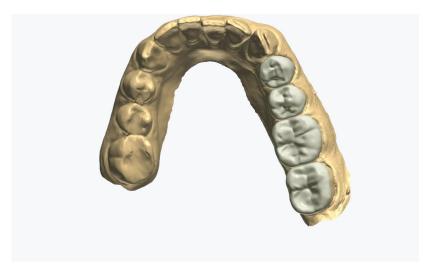
Fig. 9

Designs following adaptation by running the virtual articulator. (Fig. 9)

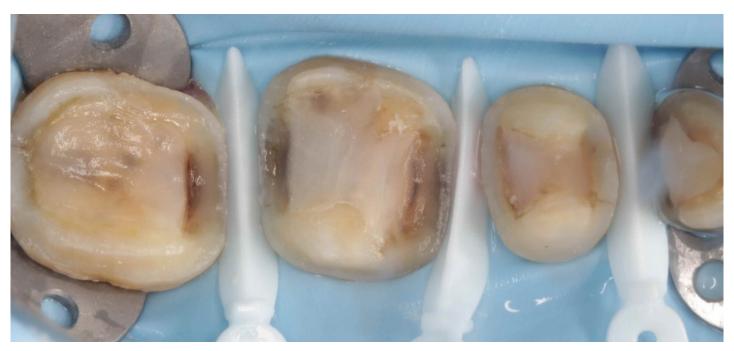
Fig. 10

The tooth surface was then treated with a bonding agent which was air thinned and left uncured and a dual cure cement with bond activator was applied to the fit surface of the restorations and they were seated. (Fig. 10)
